**ASBESTOS HAZARD EMERGENCY RESPONSE ACT
MANAGEMENT PLAN
FOR**

**Springfield Prep Charter School
2071 Roosevelt Avenue
Springfield, Massachusetts**

August 19, 2021

Project # 21353

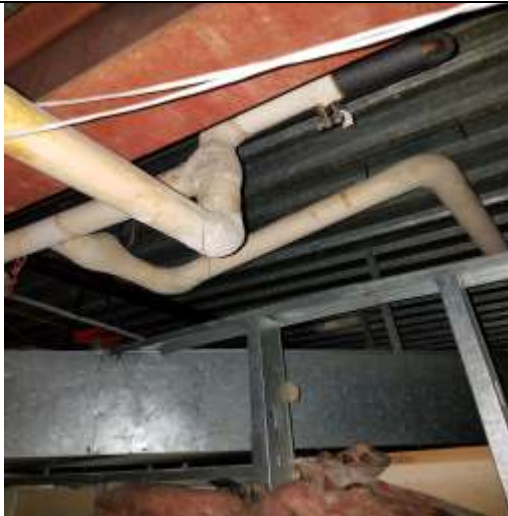
Asbestos pipe fittings in cafeteria plenum

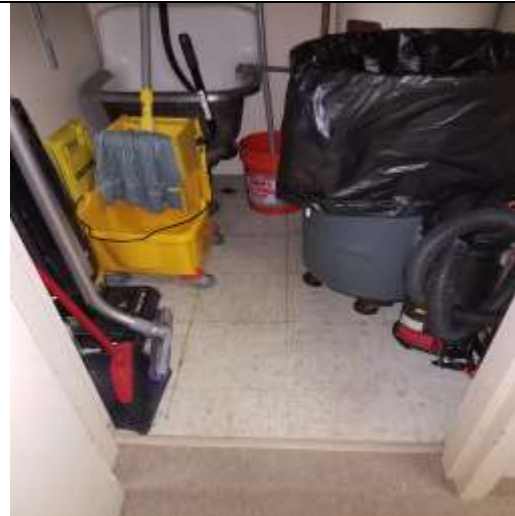
Janitor closet 2071, asbestos floor tile/mastic

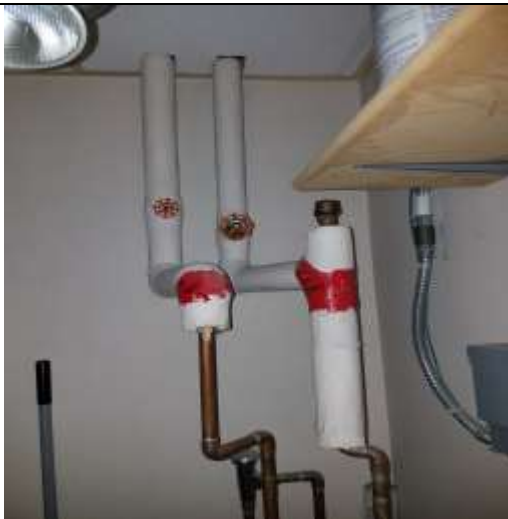
Janitor closet 2071, asbestos pipe fittings

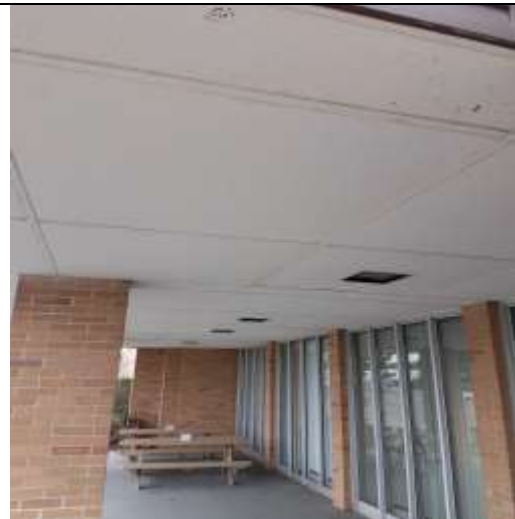
Asbestos ceiling panels at rear entrance

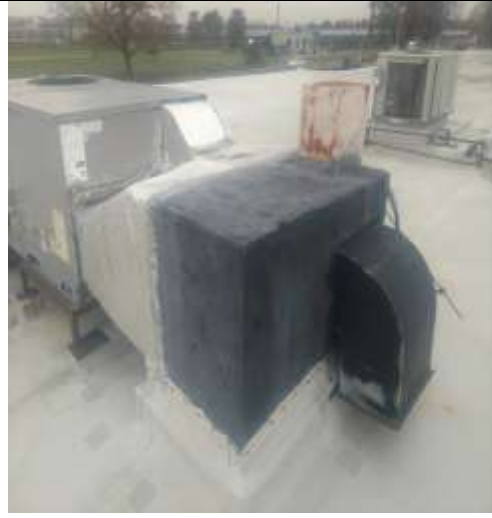
Tar mop on duct, asbestos

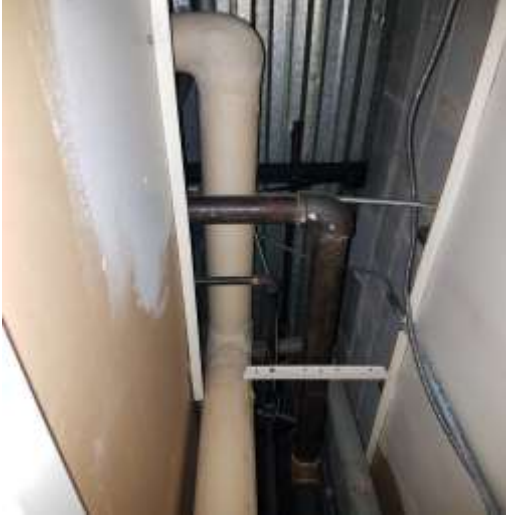
Kindred space, asbestos fitting

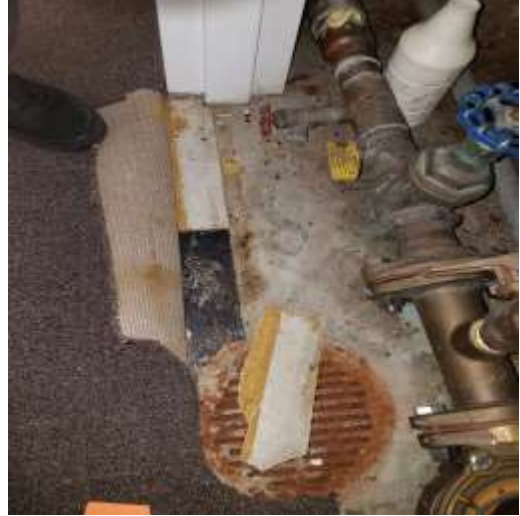
Kindred floor tile/mastic under carpet, asbestos

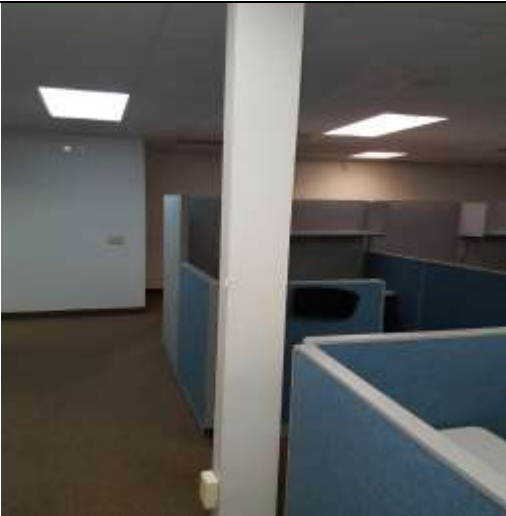
S/E vacant space with asbestos JC

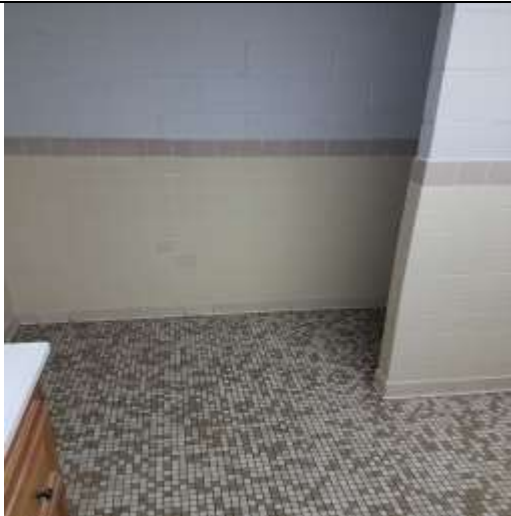
Lead paint glaze in bathroom ceramic wall

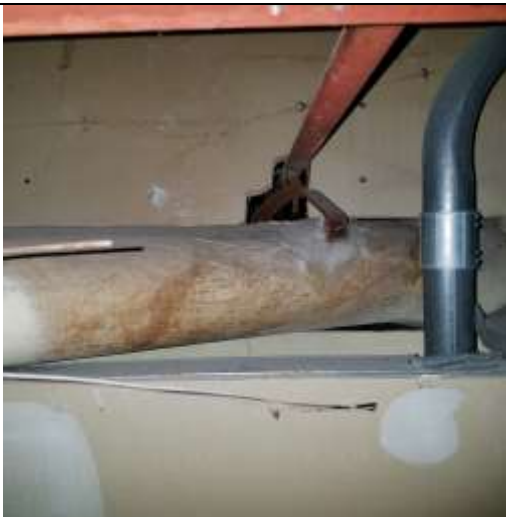
Asbestos mud on drain hanger

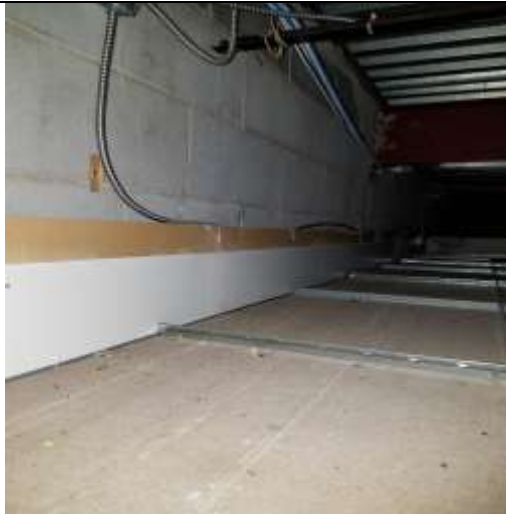
S/E vacant section outer wall, asbestos JC

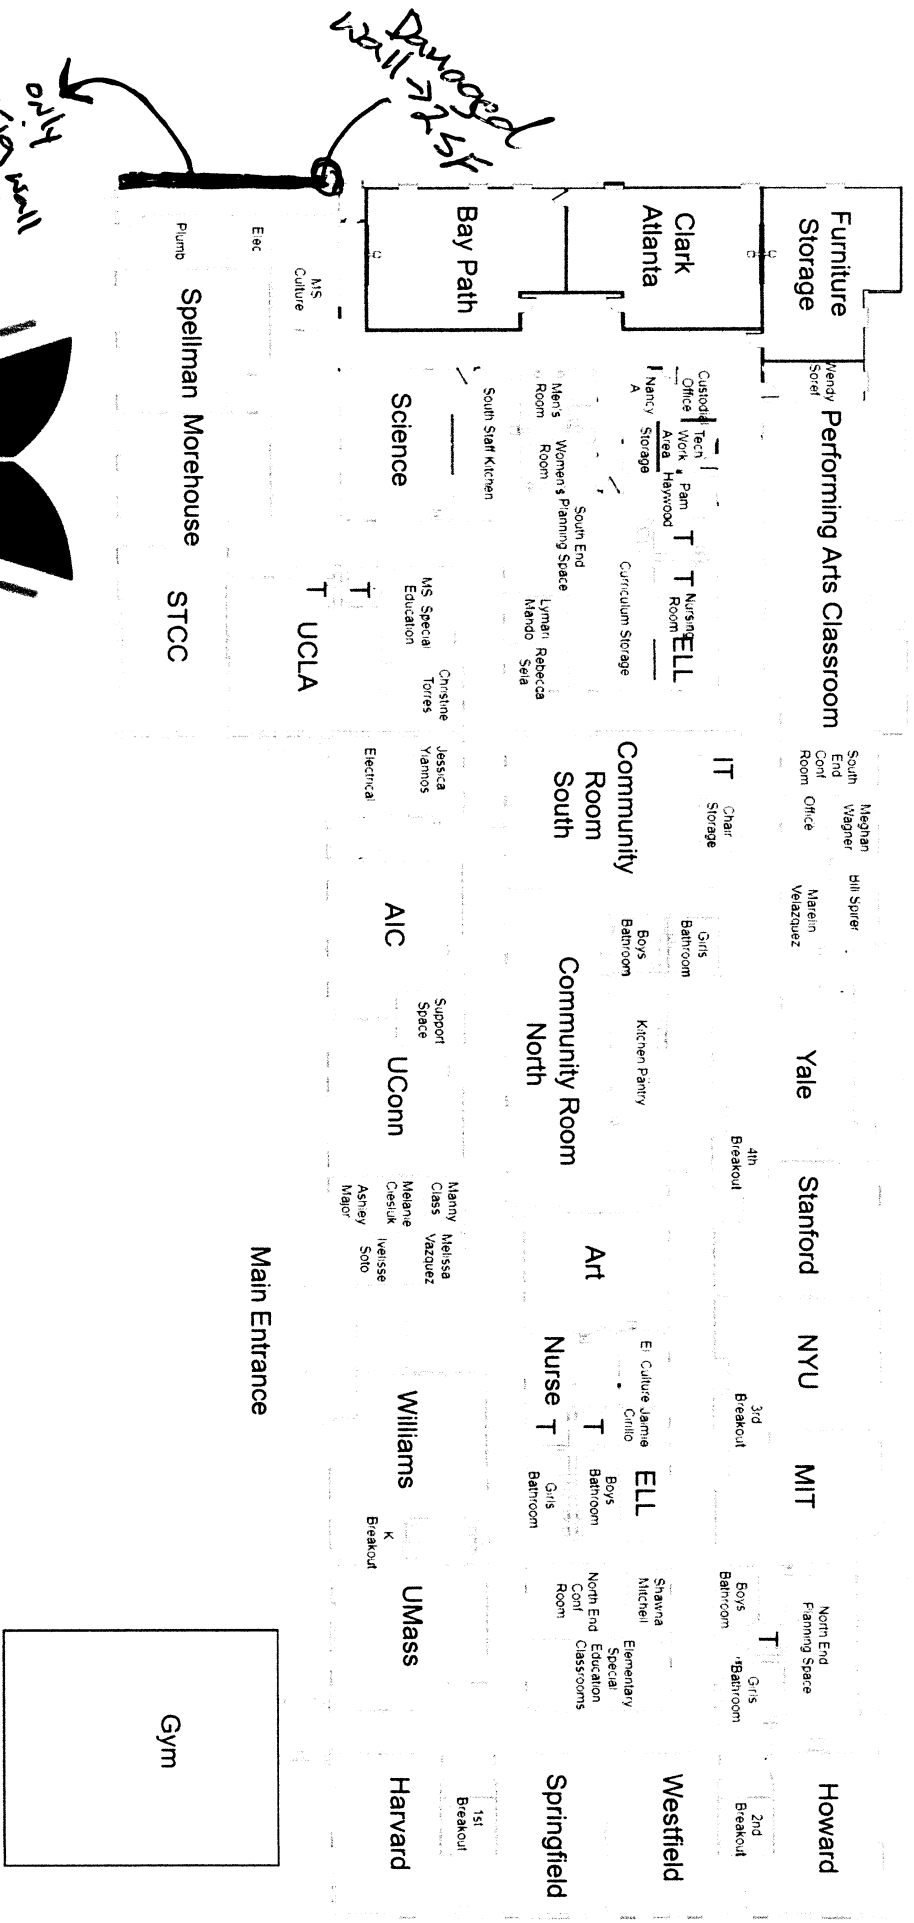
APPENDIX C
Floor Diagram Detailing Remaining Known ACBM

The only known ACBM remaining in the school as of August 2021 is non-friable joint compound an associated gypsum wallboard in the southeast utility rooms and corridor. The gypsum board/joint compound has limited damage in a corner of the space that is approximately 2 sf *(see photo and floor Plan)*.

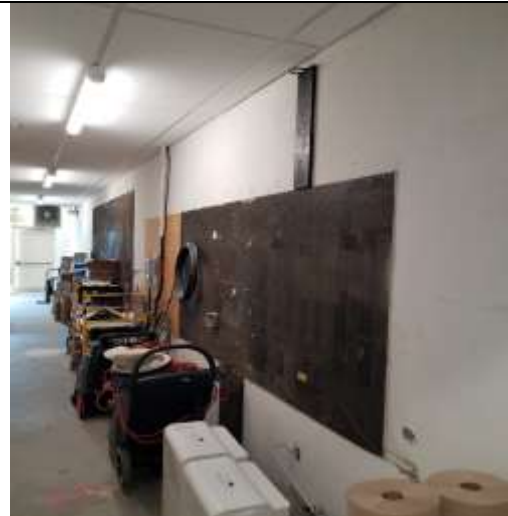
Outer south wall, not removed, asbestos JC

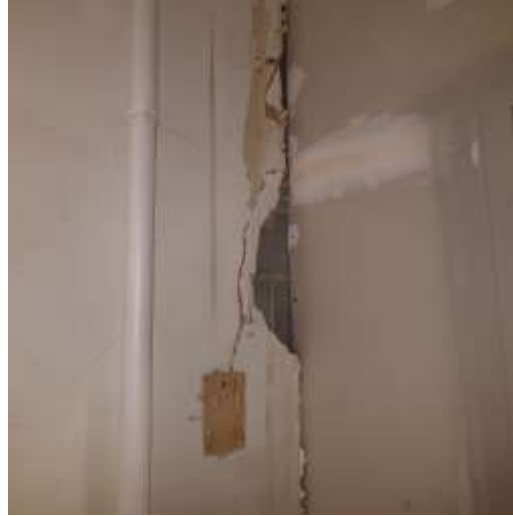
Existence of Barriers: None
Abnormal Access Features: None
Air Erosion: Low
Maintenance Activities: Low
Vandalism: Low
Potential for Fiber Release: Low
Comments: The material is in poor condition in corner

Water: Percentage: < 1%
Physical: Percentage: < 5%
Probable Source of Damage: Wear and tear, contact damage in limited locations

South wall with damage, asbestos

Recommended Response Action: Operations and Maintenance Program
Response Action Rationale: The material is in good condition, except for a 2 sf corner section, thus, repair the damaged section and properly maintain the material in-place as part of the O&M Program is appropriate.

<u>Priority Schedule</u>	<u>Type Of Material</u>	<u>Recommended Response Action</u>
1.	Joint Compound and associated gypsum wallboard	Operations and Maintenance Repair damaged section
